A. RUTECKA*, Z.L. KOWALEWSKI**, K. MAKOWSKA**, K. PIETRZAK**, L. DIETRICH*

FATIGUE DAMAGE OF Al/SiC COMPOSITES – MACROSCOPIC AND MICROSCOPIC ANALYSIS

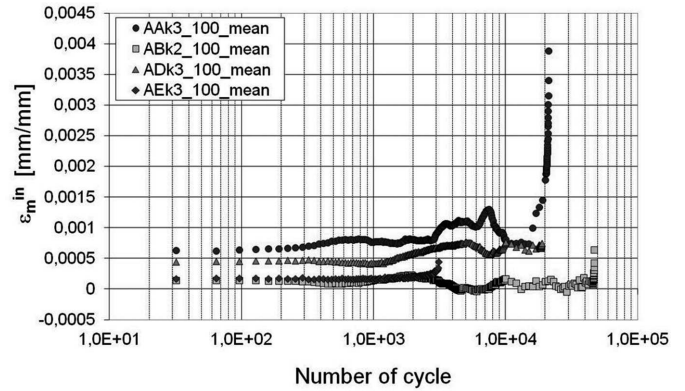
Fig. 1. Mean inelastic strain for Al/SiC composite (second series) tested at stress amplitude equal to 100 MPa. AAK3 – Al matrix, ABk2 – Al+2,5%SiC, ADk3 – Al+7,5%SiC, AEK3 – Al+10%SiC

For the second series of composites it was possible to apply higher stress amplitude equal to 100 MPa. Unfortunately, mean inelastic strain not only increased but also decreased during subsequent cycles (Fig. 1), which made it impossible to use simple mean inelastic strain as a fatigue damage indicator.

Looking at the mean inelastic strain (Fig. 1) and inelastic strain amplitude (Fig. 2) variations during subsequent cycles, one can conclude that in majority cases the highest values were obtained for the matrix material in comparison to the composites. That means higher fatigue strain resistance for aluminium reinforced by SiC in comparison to the aluminium itself. It is worth to notice that for the Al+2,5%SiC similar values of the mean inelastic strain were obtained as those for the Al+10%SiC achieved. However, the former composite exhibited higher lifetime what means its better fatigue properties.

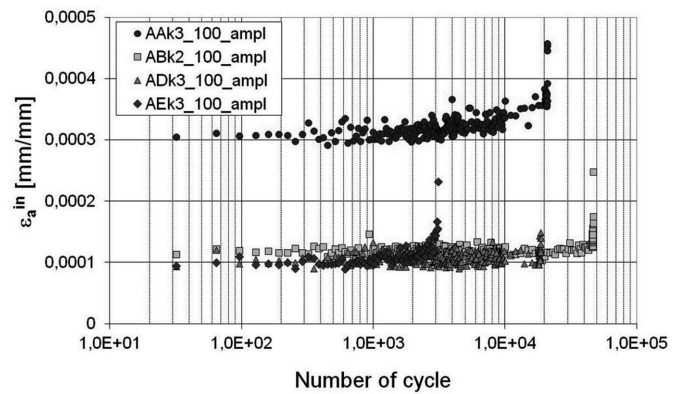
Fig. 2. Inelastic strain amplitude for Al/SiC composite (second series) tested at stress amplitude equal to 100 MPa. AAK3 – Al matrix, ABk2 – Al+2,5%SiC, ADk3 – Al+7,5%SiC, AEK3 – Al+10%SiC

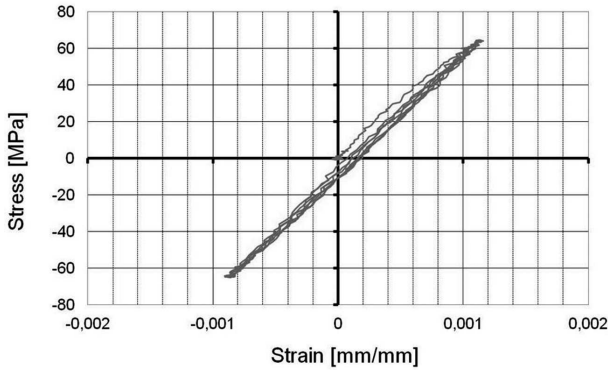
Fig. 3. Hysteresis loops for the initial cycles of fatigue tests. Material Al (second series) tested at stress amplitude equal to 70 MPa

Depending on the level of stress amplitude and SiC content, different changes of hysteresis loops were observed during fatigue tests. Ratcheting was the dominant damage mechanism for the matrix tested at stress amplitude equal to 70 MPa (Figs. 3 and 4). In the case of matrix tested at 100 MPa stress amplitude cyclic plasticity combined with ratcheting were the main fatigue damage mechanisms (Figs. 5 and 6). The composite with 7,5% of SiC tested at 70 MPa exhibited ratcheting towards negative strain values (Fig. 7), while hysteresis loops during fatigue tests of the Al+10%SiC under the same stress amplitude nearly did not change during subsequent cycles (Fig. 8). The Al+2,5%SiC tested at the stress amplitude equal to 100 MPa exhibited cyclic plasticity combined with ratcheting (Figs. 9 and 10). In cases of higher SiC content an influence of damage mechanisms on hysteresis loops was smaller.

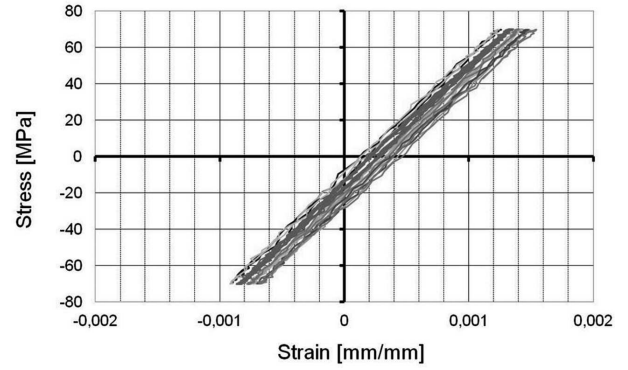
Fig. 4. Hysteresis loops for the cycles over 100 of fatigue tests. Material Al (second series) tested at stress amplitude equal to 70 MPa

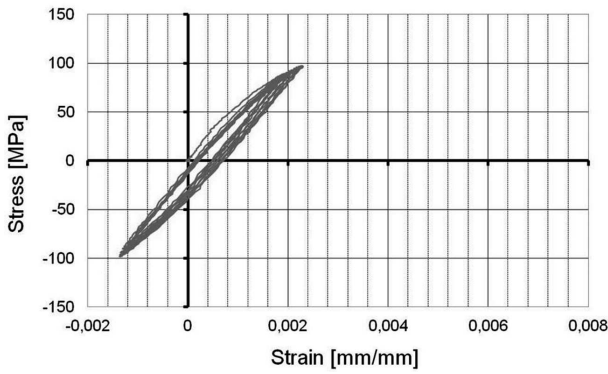
Fig. 5. Hysteresis loops for the initial cycles of fatigue tests. Material Al (second series) tested at stress amplitude equal to 100 MPa

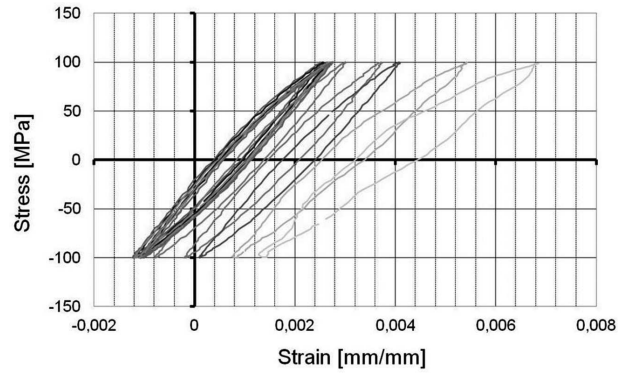
Fig. 6. Hysteresis loops for the cycles over 100 of fatigue tests. Material Al (second series) tested at stress amplitude equal to 100 MPa

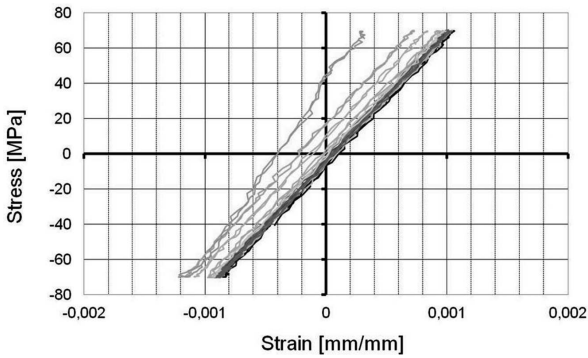
Fig. 7. Hysteresis loops for the cycles over 100 of fatigue tests. Material Al+7,5%SiC (second series) tested at stress amplitude equal to 70 MPa

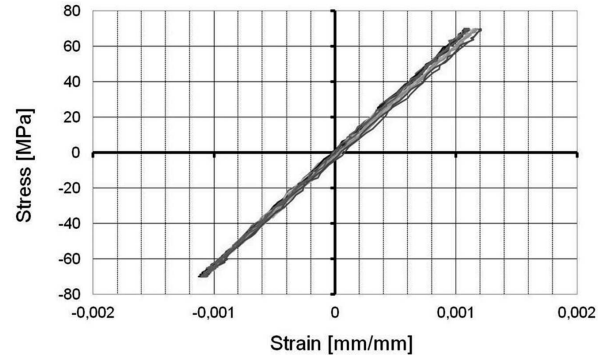
Fig. 8. Hysteresis loops for the cycles over 100 of fatigue tests. Material Al+10%SiC (second series) tested at stress amplitude equal to 70 MPa

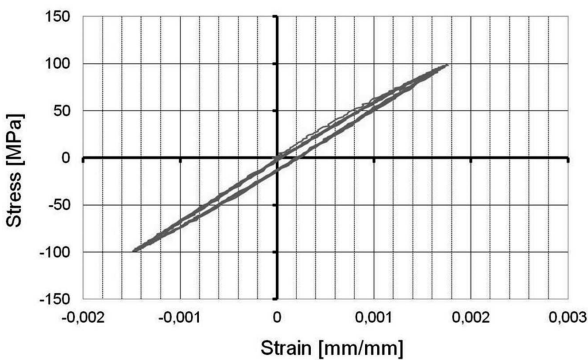
Fig. 9. Hysteresis loops for the initial cycles of fatigue tests. Material Al+2,5%SiC (second series) tested at stress amplitude equal to 100 MPa

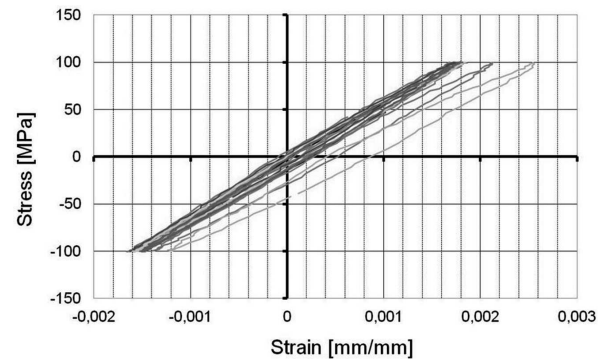
Fig. 10. Hysteresis loops for the cycles over 100 of fatigue tests. Material Al+2,5%SiC (second series) tested at stress amplitude equal to 100 MPa

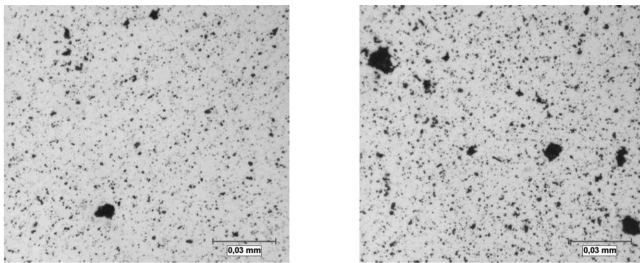
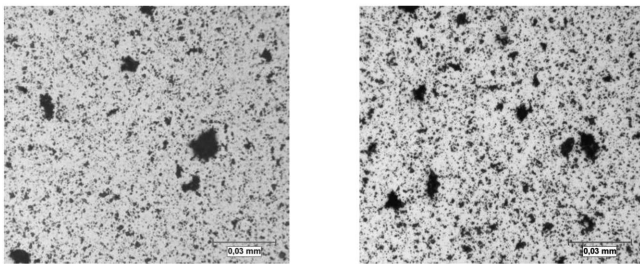
a) Al+2,5% SiC, magn. 500x

b) Al+5% SiC, magn. 500x

c) Al+7,5% SiC, magn. 500x

d) Al+10% SiC, magn. 500x

Fig. 11. Images of microstructure: transversal cross sections of Al/SiC composites (first series) before fatigue tests (magn. 500x)

In the first step of the investigation programme preliminary microstructural observations were carried out before fatigue tests for the first series of Al/SiC composites. Images were taken for the mutually perpendicular cross sections of rods produced using the KOBOL method. SiC particles of small sizes uniformly distributed in the composite matrix, as well as SiC particle agglomerates were observed for rods of the first series (Fig. 11). The quantity of SiC agglomerates increases for the higher SiC content. These agglomerates should be treated as microstructural defects and they can be mainly responsible for voids and cracks generation. Moreover they can affect a type of damage mechanism evolution during fatigue tests. An analysis of Al/SiC (first series) microstructure after fatigue tests was presented in the separate paper [8].

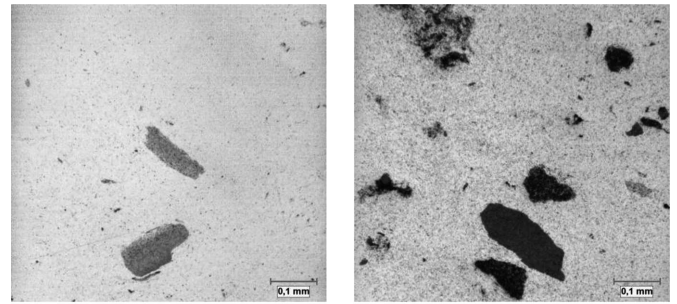
a) Al+2,5%SiC magn. 100x

b) Al+10%SiC magn. 100x

Fig. 12. Images of microstructure: transversal cross sections of Al/SiC composites (second series) before fatigue tests (magn. 100x)

Both transversal and longitudinal cross sections of the second series rods before (Fig. 12, 13) and after fatigue tests (Fig. 14, 15) were taken into account. Non-uniform distribution of SiC particles in the composites examined can be observed for the materials before fatigue tests. A tendency to form SiC agglomerates is stronger for the second series of composites, that it is clearly shown either on transversal or longitudinal cross sections. It is easy to notice that the quantity and size of SiC agglomerates increase with an increase of SiC content in the composites.

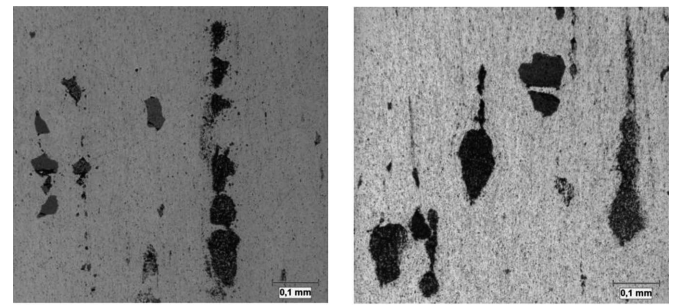
a) Al+2,5%SiC magn. 100x

b) Al+10%SiC magn. 100x

Fig. 13. Images of microstructure: longitudinal cross sections of Al/SiC composites (second series) before fatigue tests (magn. 100x)

A distribution and orientation of the reinforcing agglomerates formed during composites production, especially visible on the longitudinal cross sections (Fig. 13) may be treated as the main disadvantageous microstructural effect.

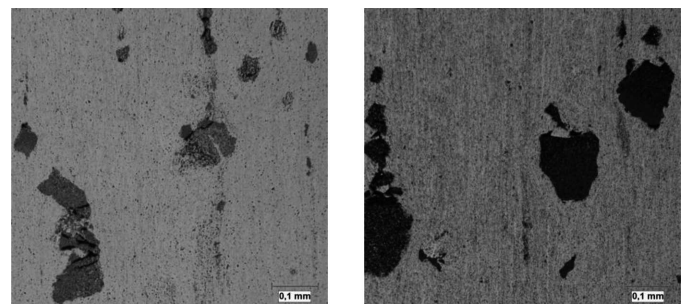
a) Al+2,5%SiC magn. 100x

b) Al+10%SiC magn. 100x

Fig. 14. Images of microstructure: longitudinal cross sections of Al/SiC composites (second series) after fatigue tests (magn. 100x)

Microstructural images observed after fatigue tests for Al/SiC composites (second series – Fig. 14) confirmed such conclusion since the voids and cracks were mainly distributed in places of SiC agglomerates location.

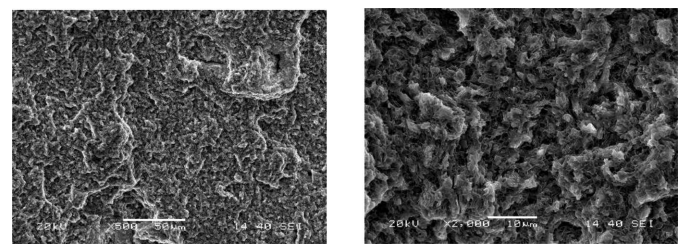
a) magn. 500x

b) magn. 2000x

Fig. 15. Fracture images after fatigue tests for Al+7,5% SiC composite (second series) (SEM)

An analysis of images presenting fracture surfaces after fatigue tests for Al+SiC composites (second series) (Fig. 15) leads to the remark that the fatigue fracture type was observed in majority of tests carried out. Voids and cracks were identified in the fracture areas.
